REPORT OF MARINE SURVEY OF THE VESSEL

1990 Catalina 42

CONDUCTED ON
August 28, 2009

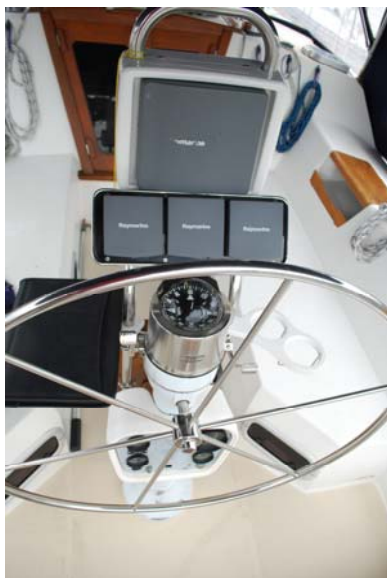
Throttle control at helm.

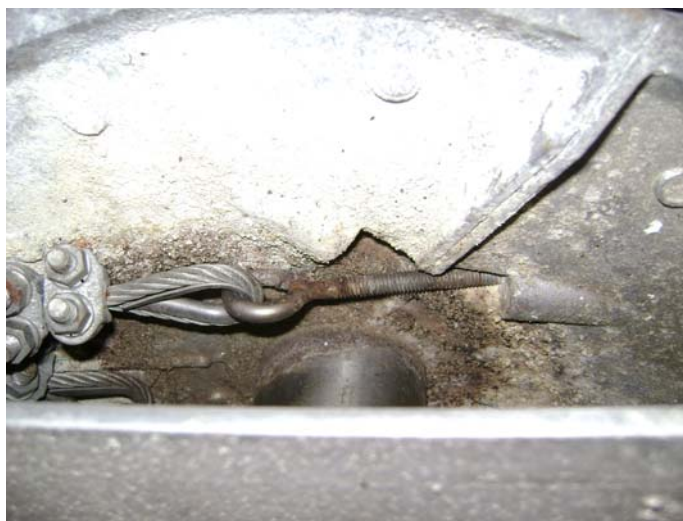
Edison pedestal with equipment pod and destroyer wheel. Pulleys, cable and chain in pedestal and under cockpit sole, quadrant visible under helm seat, appeared serviceable. Noted some play in wheel, some slack in cable, and bolt holding cable to quadrant backed out some. Recommend monitoring and consider tightening bolt and cable.

Steering quadrant bolt backing out.

5. Steering cable bolt backing out, loose play in wheel. Adjust bolt and tension. (page 18)
