REPORT OF MARINE SURVEY OF THE VESSEL

**1990 Catalina 42**

CONDUCTED ON  
August 28, 2009

Acting at the request of \_\_\_\_\_, the vessel ““\_\_\_\_\_”” was surveyed on Friday August 28, 2009 from 10:30 to 18:00. The “in the water” inspection was conducted at the boat’s home slip in \_\_\_\_\_, Pasadena, Maryland. In attendance: \_\_\_\_\_, Jean Levine and Jeff Grossman. The reason for the survey was to ascertain the physical condition and value of the vessel for pre-purchase evaluation. Heavy cloud cover with intermittent rain accompanied by lightening prevented the use of a moisture meter. The “out of water” inspection of below the waterline machinery was conducted from 13:30 to 15:00 in the slings of the Travel lift. The vessel was pressure washed by employees of the \_\_\_\_\_ Marine Yard at this time. Afterward the vessel was re-floated and a sea trial was conducted in the waters of the Patapsco River from 15:00 until 16:30. The HIN CTYT0136G990 was verified from the manufacturers ID plate on the transom. The engraved HIN on the starboard stern quarter was worn and illegible. The vessel documentation expired June 2007, no current registration numbers sighted on the vessel.

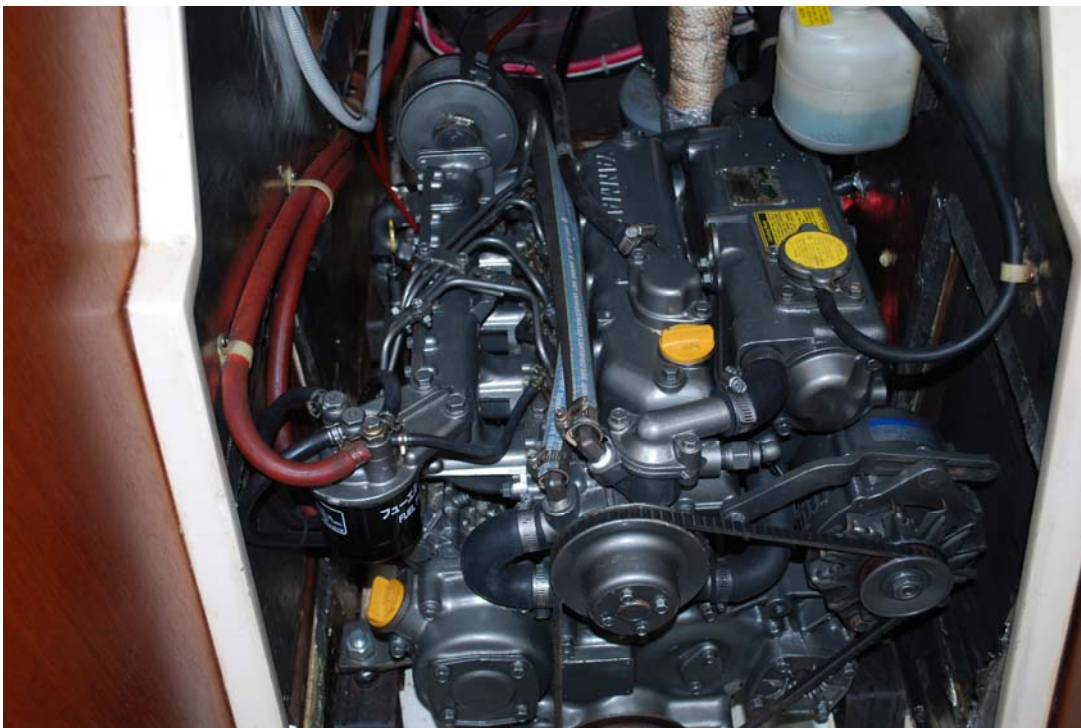
Closed reservoir type cooling with raw water cooled exhaust. Observed raw water inlet seacock and sea strainer, reinforced hoses single clamped and bulging. Replace and double clamp hoses from intake sea cock to strainer and from strainer to engine. The exhaust elbow had no visible signs of corrosion and the reinforced hoses were properly double clamped.

3. Engine raw water intake hose bulging from sea cock to strainer and from strainer to engine. Replace with new; in addition recommend replacing strainer with more visible basket. (page 16)

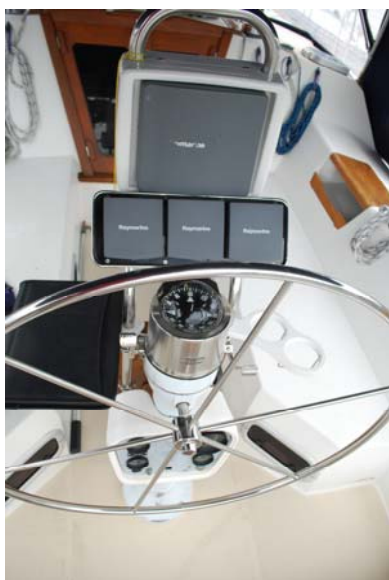
Throttle control at helm.

8. Windex at mast head missing port tacking angle square. (page 17)
9. Throttle controls operated but transmission lever stiff. (page 18)
10. Recommend placing partner wedges where mast passes through deck opening. (page 20)

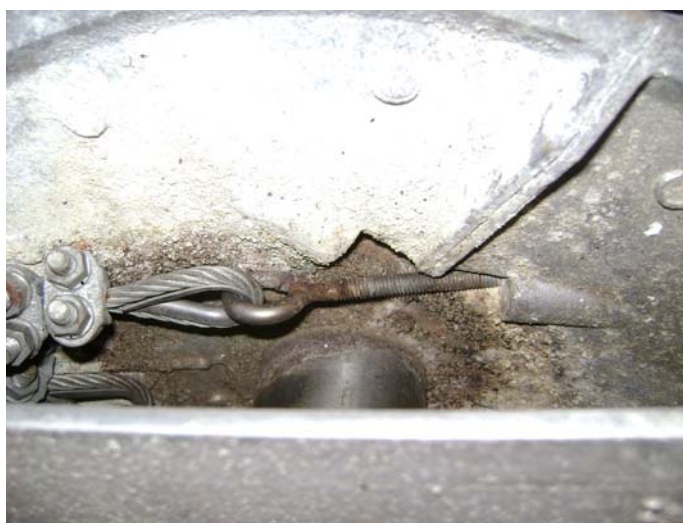
Edison pedestal with equipment pod and destroyer wheel. Pulleys, cable and chain in pedestal and under cockpit sole, quadrant visible under helm seat, appeared serviceable. Noted some play in wheel, some slack in cable, and bolt holding cable to quadrant backed out some. Recommend monitoring and consider tightening bolt and cable.

Steering quadrant bolt backing out.

5. Steering cable bolt backing out, loose play in wheel. Adjust bolt and tension. (page 18)
